Manhole Inspection Summary

Manhole # S19Y__004MH

Insp Date: **6/5/08 9:07 AM**

Location Address: **1808 sexton st**

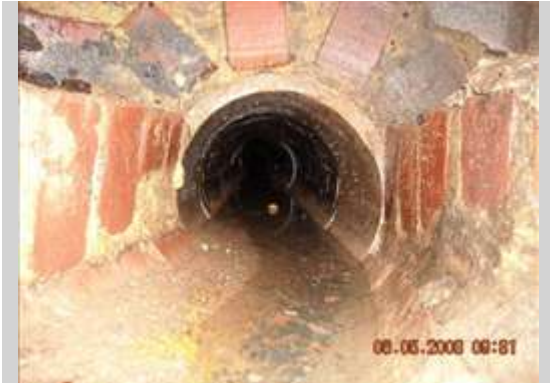
12 O'Clock Outflow

8 in. Circular Gravity Sewer
Pipe Out @ 12 O'Clock

Pipe Height: **8.4** (in.) Rod and Bar (Angled)
Pipe Material: **Clay** ☐ Pipe Lined
Invert Depth: **8.69** (ft.) Flow Characteristics: **Slow**
Deposits: ☒ None ☐ Mud ☐ Sludge ☐ Debris ☐ Grease
Silt Depth: **0** (in.) Deposits Extent:
Infiltration: **None** Pipe Seal Cond: **Sound**

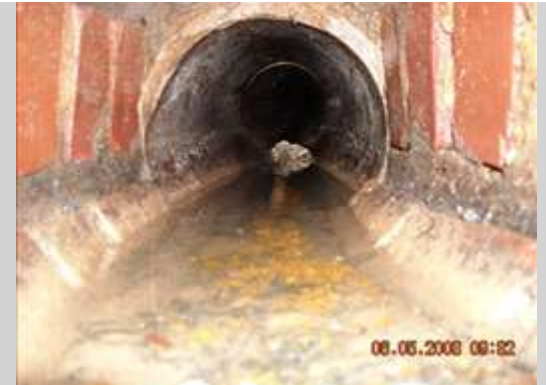
9 O'Clock Inflow

8 in. Circular Gravity Sewer

Pipe In @ 9 O'Clock

Pipe Height: **8.4** (in.) Rod and Bar (Angled)

Pipe Material: **Clay** ☐ Pipe Lined

Infiltration: **None** Pipe Seal Cond: **Sound**
